# European Radon Solutions Database

CZ/CS/03

**SUB-SLAB DEPRESSURIZATION BASED ON PERFORATED TUBES DRILLED FROM EXTERNAL CHASE**

Czech Republic

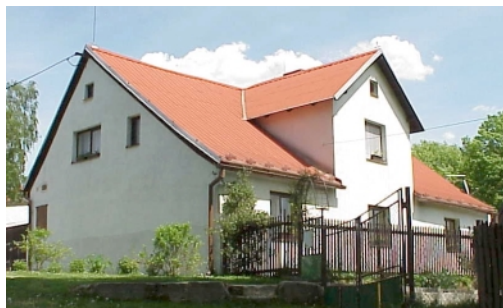
Front view of a house

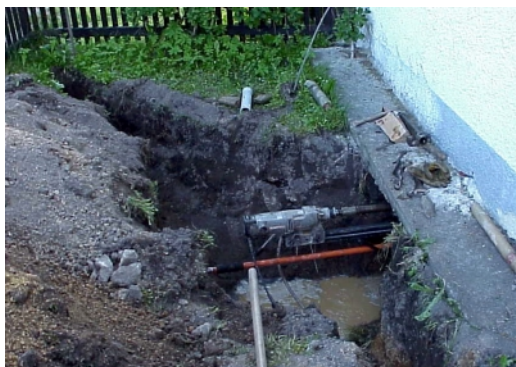
Drilling of perforated tubes into the sub-floor layer from the chase excavated along one side of the house. The chase continues to the corner of the garden, where the fan will be located.

The soil ventilation system consists of three perforated tubes that were drilled from the external chase excavated along one side of the house into the sub-floor layers beneath the habitable rooms (each tube beneath one room). Horizontal PVC-U pipe connects the drilled tubes to the fan that is located at the corner of the garden.

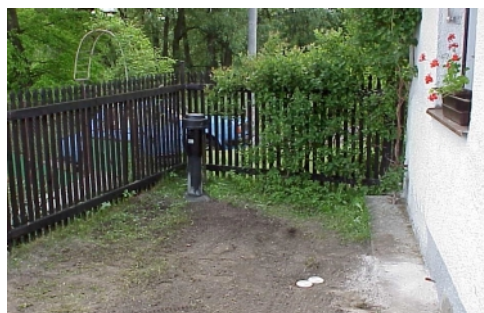
Fan located at the corner of the garden, well away from the nearest window.

To minimise negative effects of the soil ventilation the fan is switched to intermittent operation. Operating periods are adjusted according to continuous measurements of indoor radon concentration.
