European Radon Solutions Database

Case Study

CZ/CS/05

RECONSTRUCTION OF FLOORS IN COMBINATION WITH SOIL DEPRESSURIZATION

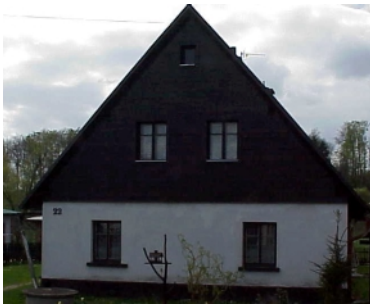
Front view of a house
