European Radon Solutions Database

Existing Buildings

Case Study

Sealing of different parts of building structure.

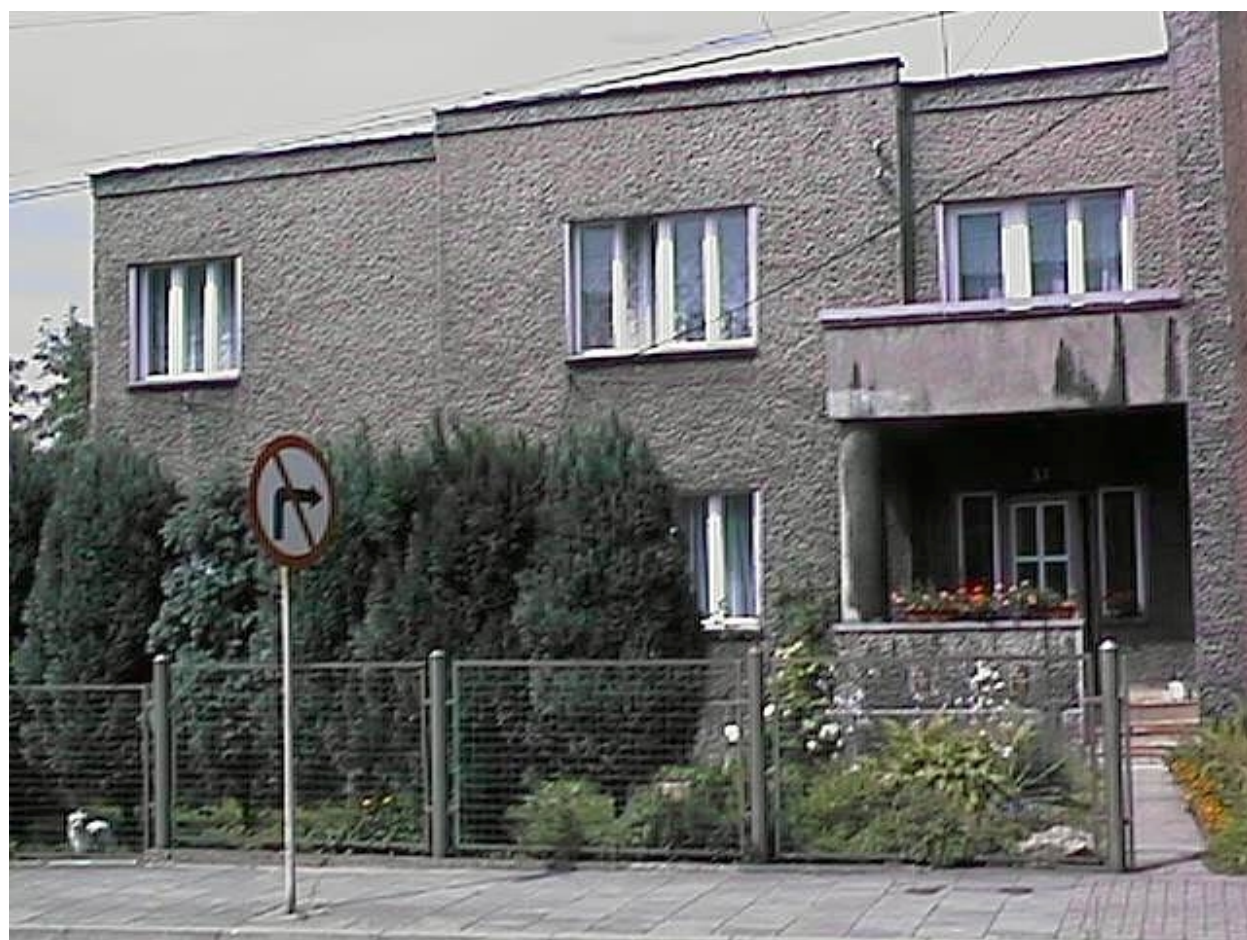
Illustration

This project comprises single family house, built in 1930, located in Piekary Slaskie in Upper Silesia (South Poland). Constructed with bricks and in-situ concrete ground floor.

Investigated building is situated in area strongly affected by mining activity. Damages of building structure caused by the effects of subsiding of surface such as cracks and fissures were observed. Radon concentration was measured before and after mentioned above damages were repaired.

Re-testing has shown that the reparation (sealing) of fissures in building structure is having a significant effect on reduction of radon concentration in the building
