European Radon Solutions Database

Case Study

CZ/CS/02

SUB-SLAB DEPRESSURIZATION BASED ON PERFORATED TUBES DRILLED FROM INTERNAL CHASE

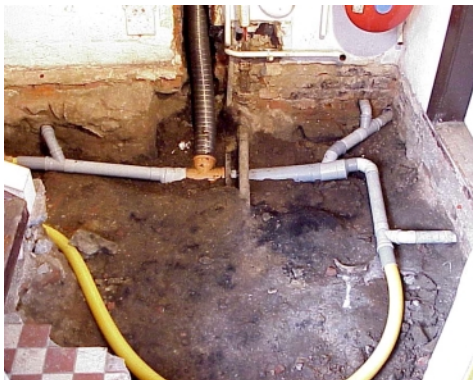
Chase excavated in the entrance hall served for drilling of perforated tubes into the sub-floor layers under the adjacent rooms. Horizontal PVC-U pipe connects the drilled tubes to the vertical exhaust from flexible rustless pipe, which is inserted into a free flue.

The soil ventilation system consists of four perforated tubes that were drilled from the chase excavated in the entrance hall into the sub-floor layers beneath the adjacent habitable rooms (each tube beneath one room). Horizontal PVC-U pipe connects the drilled tubes to the vertical exhaust from flexible rustless pipe. Vertical exhaust pipe is inserted into a free flue and ends with a roof fan above the chimney.

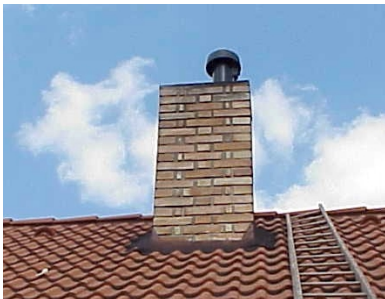
Vertical exhaust pipe ends with a roof fan above the chimney.

To minimise negative effects of the soil ventilation the fan is switched to intermittent operation. Operating periods are adjusted according to continuous measurements of indoor radon concentration.
