# European Radon Solutions Database

### Case Study

CZ/CS/06

**POSITIVE PRESSURIZATION**

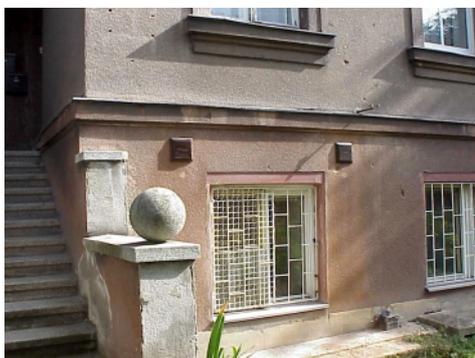
Front view of the basement flat. On the left side of the kitchen window there is an inlet for the ventilation unit and on the right side of the window there is an outlet from the cooker hood.

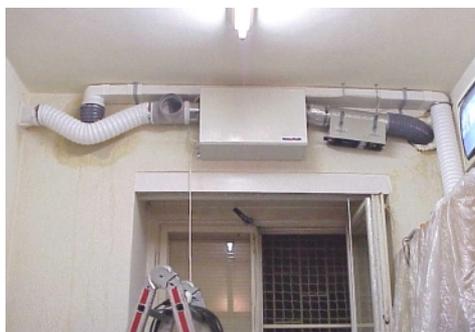
Ventilation unit above the kitchen window with the heater for preheating of the outdoor air on the right side. On the left side the distribution pipe continues through the partition wall to the living room. The rectangular pipe above the unit is an exhaust pipe from the cooker hood.

Increased ventilation was ensured by means of a ventilation unit Doctor Flat (Flatmaster 5+), which was installed in the kitchen above the window. On the ventilating duct between the inlet and the unit the heater is placed for preheating of the supply air in cold seasons. The air is supplied from the unit into all habitable rooms. In each room the diffuser is installed on the ventilating duct to regulate the volume of air discharged into it.

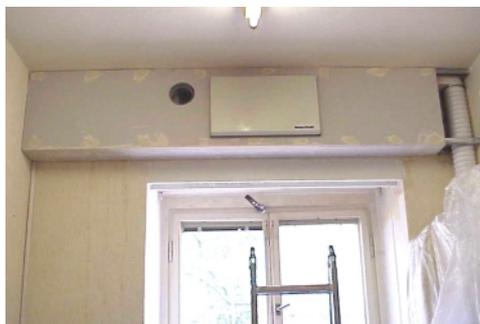
Casing of pipes made of gypsum plasterboard. An outlet into the kitchen will be provided with air diffuser.
