World Radon Solutions

Case Study

FR/CS/02

Soil Depressurisation System from a void

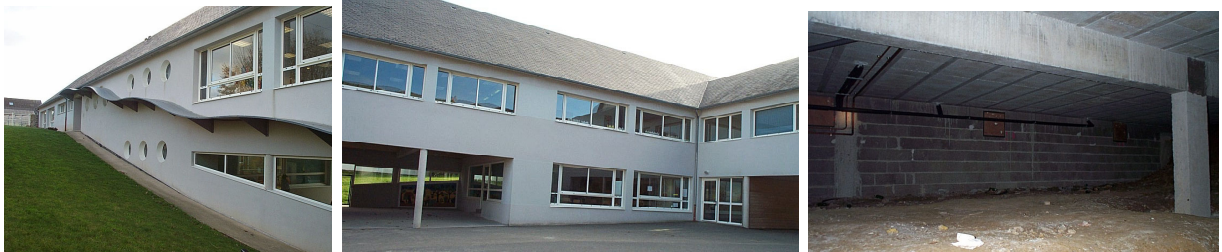
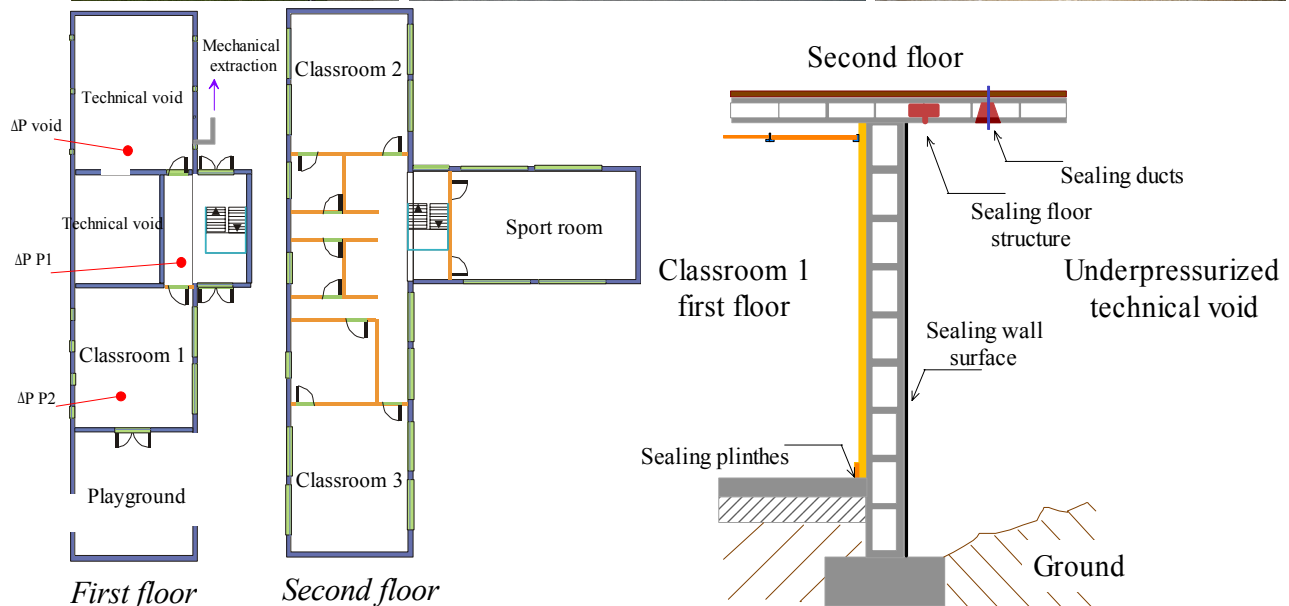
Illustration

Two levels recent school dated 1996. First floor consists in general building entrance, one classroom and accessible technical void partly buried. Building walls are made with breeze block, first floor in concrete and second floor with hollow blocks.

- Sealing works were conducted on wall surface between classroom 1 and technical void, on second floor structure, around pipes and around first floor.
- A Soil Depressurisation System has been installed. The extract point to create depressure field under basement has been connected to technical void. Natural air entrances were sealed.
- Ventilation system is planned to install with the built of a new classroom instead of playground

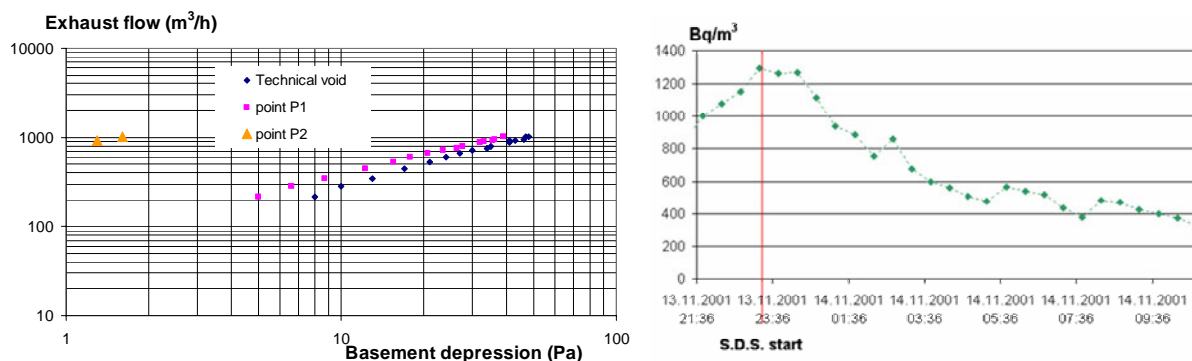
Mechanical extraction from the void has been undertaken with a variable velocity fan in order to test the basement ability to be depressurised and to dimension the necessary extraction rate. Pressure difference measurements have been done into the void, at P1, and P2. Under pressure was considered satisfactory with a 560 m³/h extract flow (2 m³/h/m²). Once this rate has been known, radon concentration has been measured once the system began to run.

Depression was easy to obtain under concrete floor in building entrance. Depression under concrete floor of classroom 1 was hard to generate. In fact, wall between classroom 1 and technical void was very air leakage. Radon decrease observed during running test should have been mainly due to air flow rate through this wall. The other walls of the void are mainly buried. A decrease of radon concentration had also been measured at second floor. That is why it has been decided to air tight this wall in order to better generate depression under classroom 1.
