World Radon Solutions Database

Mitigation of existing buildings

Case Study N° | F-03

Type | Cellar sealing and airing

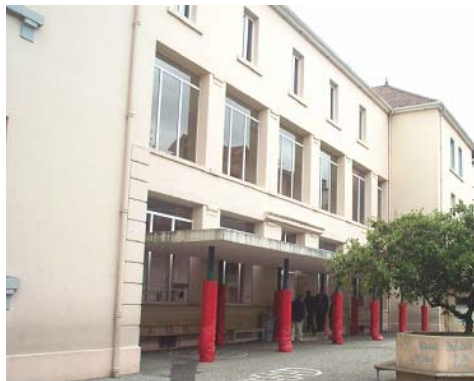
Multi-storey school

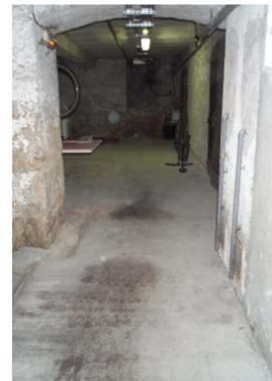
Cellar floor: concrete

The ground of the cellar has been covered with a concrete floor and with a membrane underneath (soil gas retarder). The natural airing of the cellar has been improved, by maintaining, permanently, partly opened, existing windows.
