# European Radon Solutions Database

### Case Study

**Type** Air cushion method

**Country** Sweden

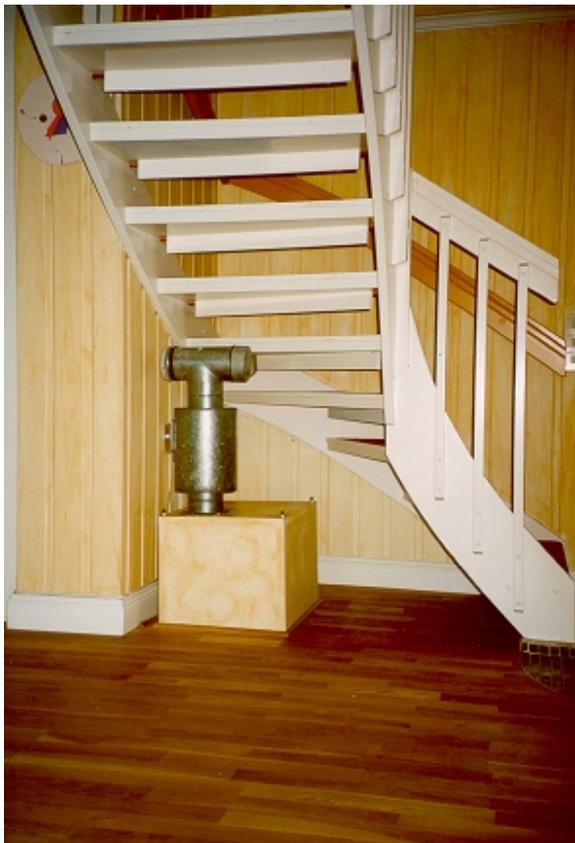
### Illustration

This semi-basement house was built in 1972 on a hillside on top of an esker, therefore on a high-risk area. Slab on ground construction with hollow-block walls in basement walls, the other walls are wooden.

The first reduction system that was installed in 1983 was a sub-slab suction system. The system had one suction point that was located in a storage room in one corner of the house. It didn't reduce the radon level, on the opposite, the radon level enhanced. In 1986 the system was replaced with a new one, which literally turned the airflow in the opposite direction. To reduce the amount of radon entering the building, sub-slab soil was pressurized with air from inside the house. This pushes away some of the radon containing air beneath the slab and decreases the air pressure to the slab from the soil. At one point in the middle of the slab a 100 W fan exhausts air from the house to the sub-slab soil. This method is called the air cushion method and has only been used in a few cases. The fan is insulated and equipped with dust filter. The dust filter prevents the sump from becoming covered with dust. This selection proved successful and effective. An advantage with the system is that the basement floor gets warmer.

The original level of radon was 2900 Bq/m<sup>3</sup>. The installation of a radon sump system resulted in levels on 3100 Bq/m<sup>3</sup>. Six follow-up measurements have been made after the new installation. All but one gives results between 40 and 110 Bq/m<sup>3</sup>. One exception was 920 Bq/m<sup>3</sup>. The explanation was that the walls in the room where the fan is were repainted and the painter had disconnected the electricity to the fan.

The dust filter must be cleaned regularly in order to maintain the effect. This type of installations has in some cases caused moisture problems.
