European Radon Solutions Database

Case Study

Radon well

Sweden

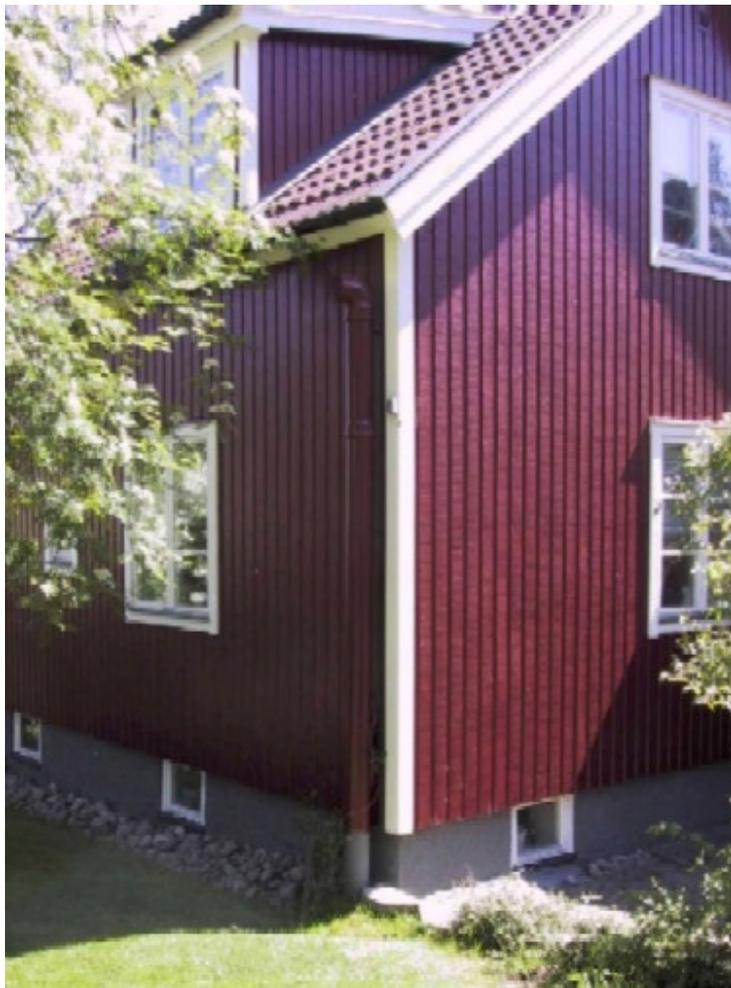
Illustration

Radon wells are suitable solutions for radon reduction in houses built on thick layers on soil with high permeability such as eskers. A radon well lowers the air pressure in a large volume of soil and the entire system can be located outdoors. A radon well was dug next to the house. A four-meter deep pipe, 40 cm in diameter was used. The lower part of the bottomless pipe is perforated. In the pipe there is a 160 W fan. The air from the well goes through a pipe and is exhausted 3 meters above ground on the northern side of the house.
